2025 Annual Conference - Innovations  
in Pavement Preservation

# Asphalt Rejuvenation

*Why Early Curve Maintenance is a Good  
Answer for PA Superpave Mixes*

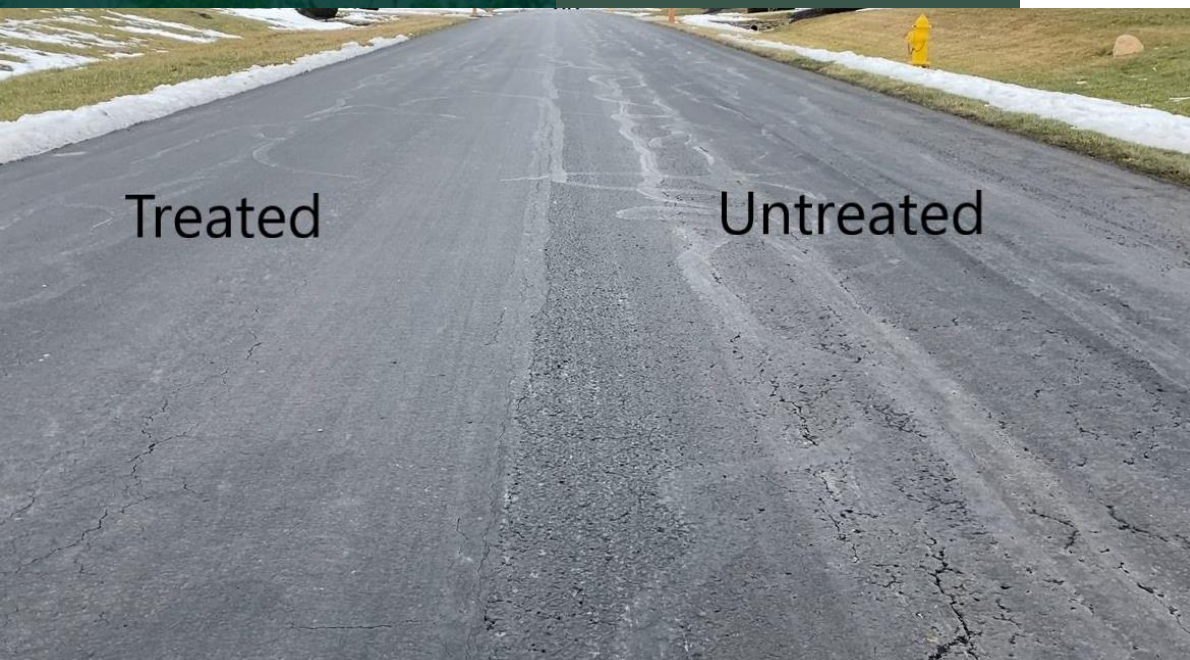
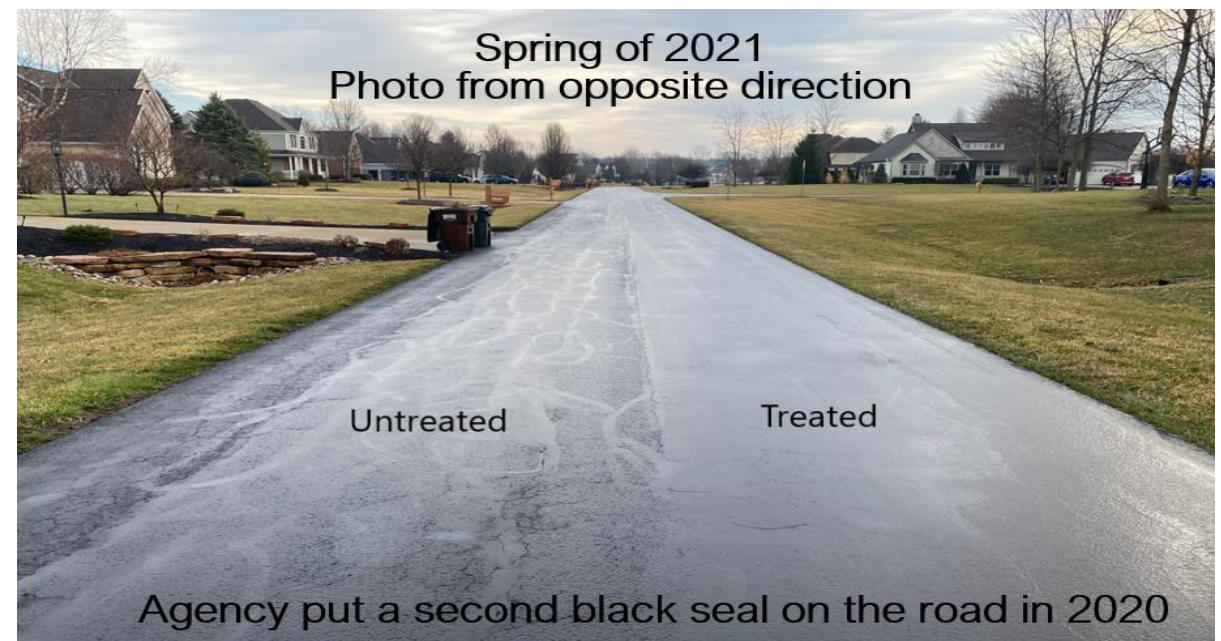
Spring of 2021  
Photo from opposite direction

Agency put a second black seal on the road in 2020

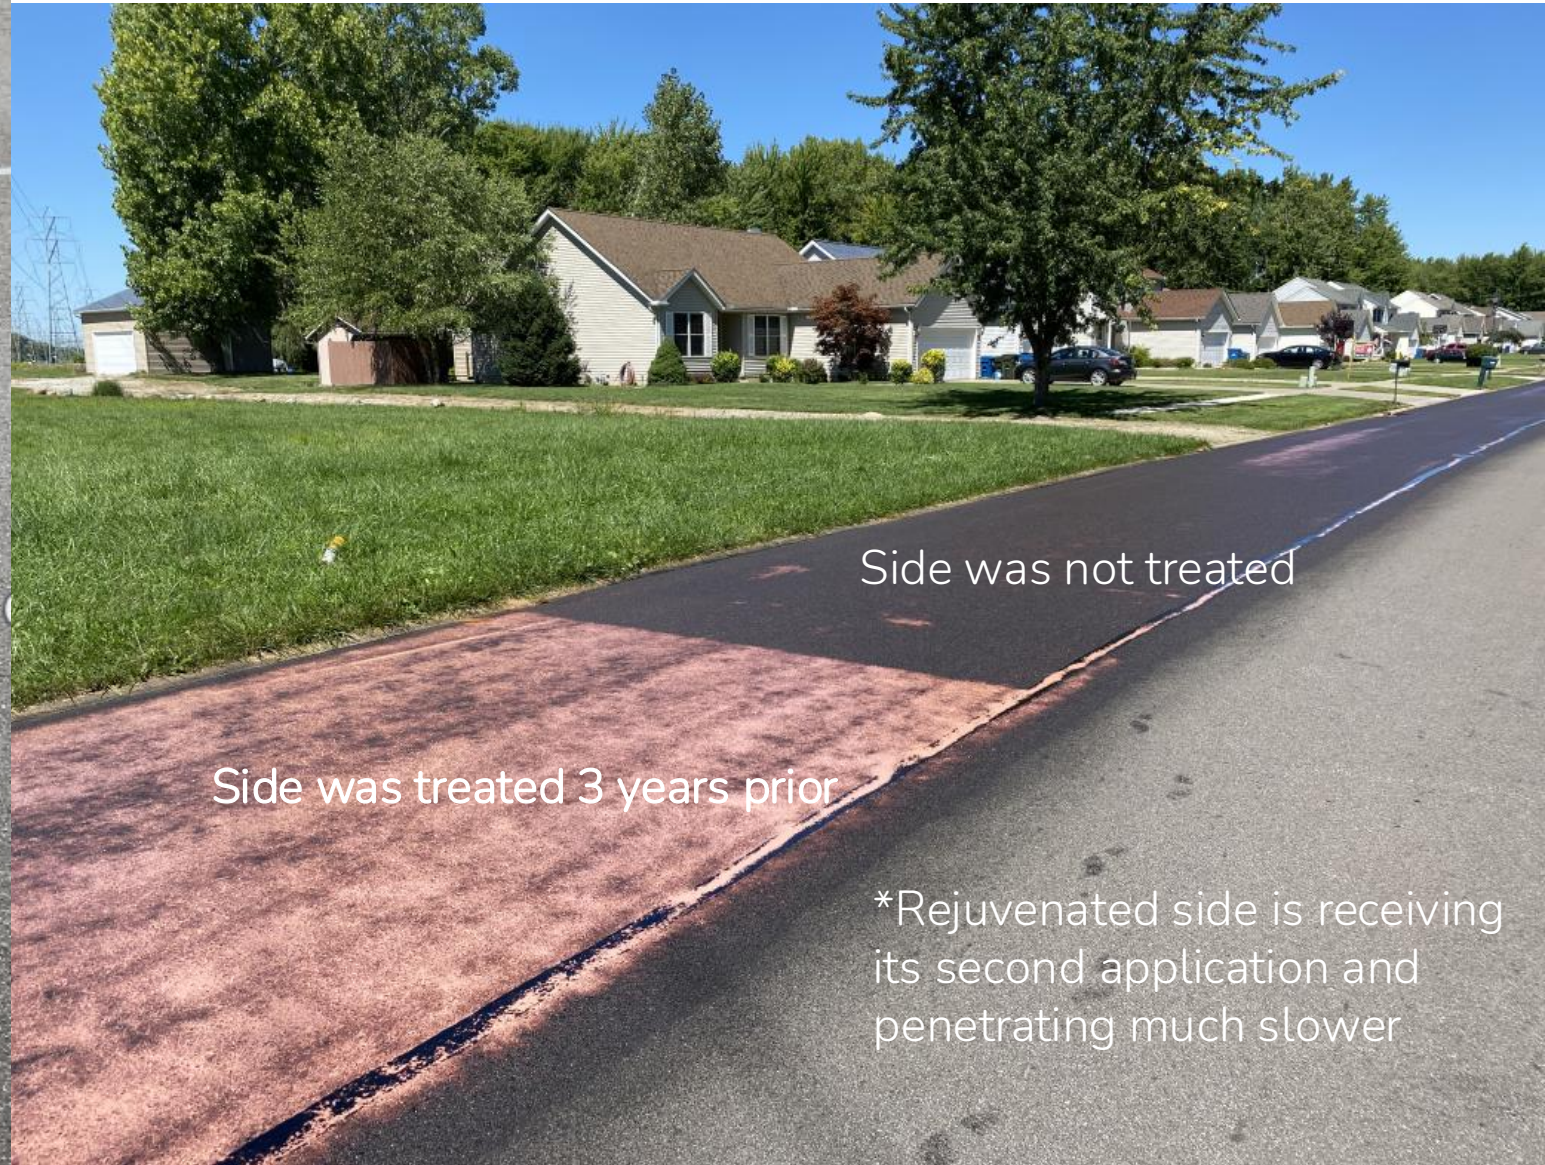
Side was not treated

Side was treated 3 years prior

\*Rejuvenated side is receiving its second application and penetrating much slower

Re-applying is not only effective but validates prior rejuvenation

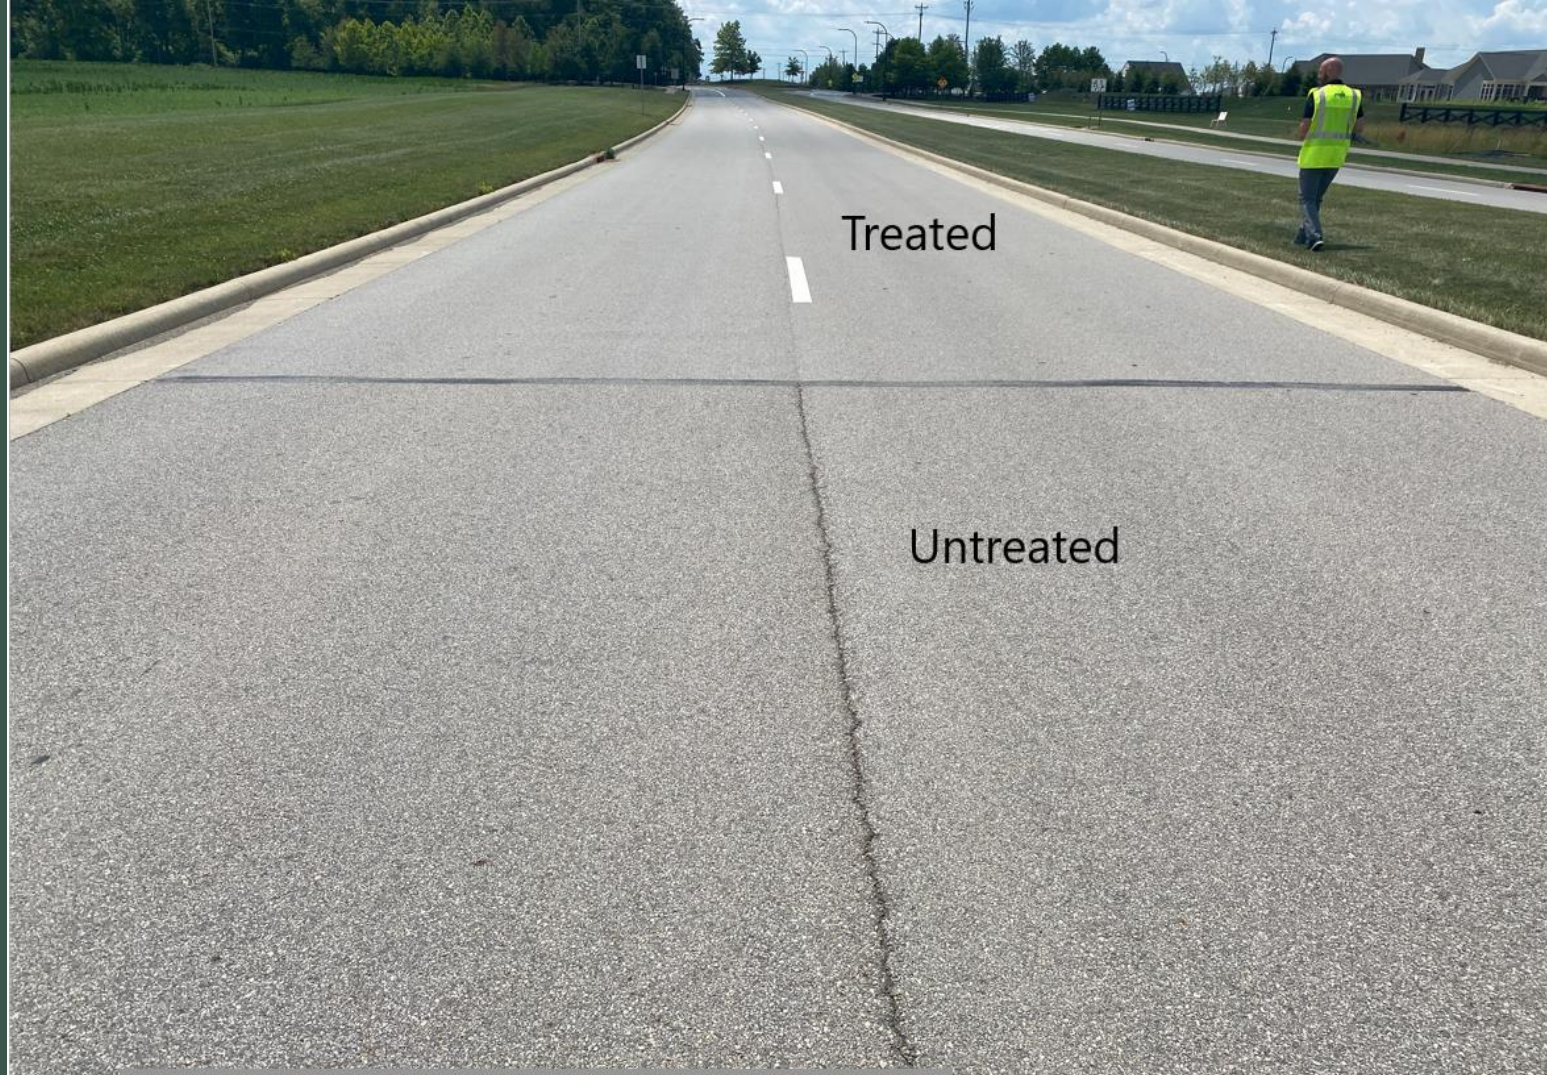
Reclamite was applied the same year this Superpave pavement was placed on the top section of photo. Bottom half of the photo was not treated

## ASSESSMENT RESULTS SAWMILL PARKWAY, TREATED

The treated segment shows minimal, light severity longitudinal cracking along the paving joint, with light severity weathering present throughout just 50% of the surface.

After documenting these distresses within the PAVER® pavement management system, the PCI of the treated segment is 95.

The untreated segment shows noticeable light and medium severity longitudinal cracking along the paving joint with light severity weathering present throughout 100% of the surface.

After documenting these distresses within the PAVER® pavement management system, the PCI of the untreated segment is 85.

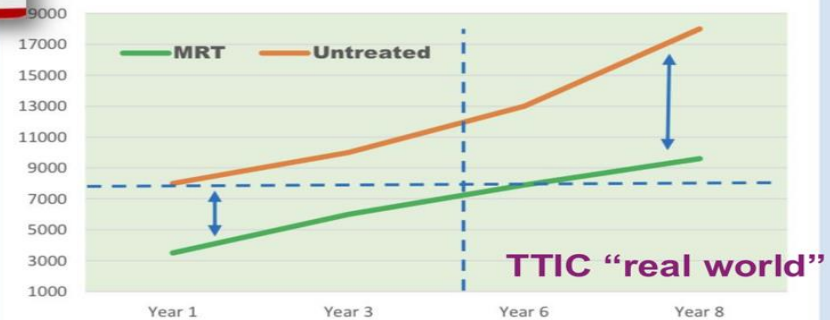
**Figure 5 – Maltene Rejuvenator (Reclamite) Study:**  
Eight Year Oxidation Rate Curves Charleston County (SC)<sup>38</sup> (in poises)<sup>39</sup>
